Navigator Home Inspections LLC

Confidential Inspection Report

November 3, 2023

Inspection: 110123_232Shoreline Address: 232 Shoreline Rd

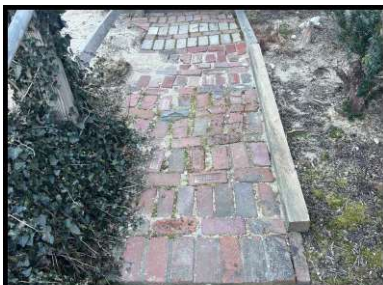
Brick Front Walkway

A [M] D NI Walkway Condition: Depressions have formed in the walkway. These will fill with rain and in winter can create icy slip and safety hazards. I recommend that you have a qualified contractor repair the walkway to maintain it in a satisfactory condition.

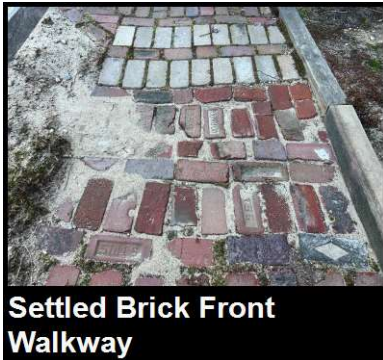
Settled Brick Front Walkway

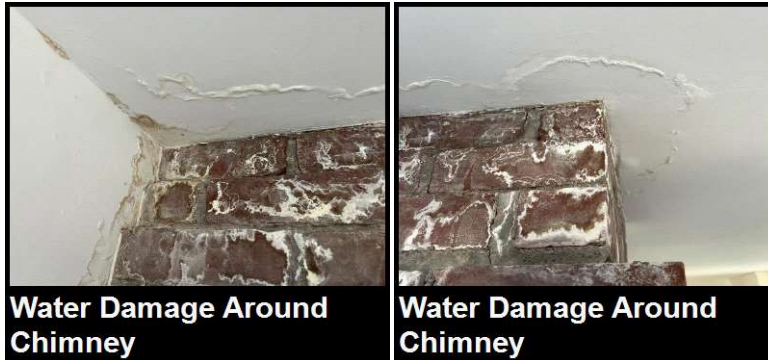
A [M] D NI Chimney Flashing: The visible flashing installed at the chimney appears to be in a functional condition at the time of inspection. Caulking/tar application was observed that typically is due to a leak repair. There were water stains observed on the interior around the chimney. I am unable to tell if this is old damage before the newer roof was installed. I recommend monitoring this area for any future leakage.

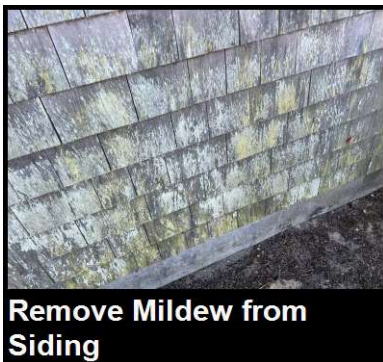
A [M] D NI **Condition Of Siding Type #1:** Exterior wall covering had areas where there appears to be algae/mildew growth. In time this can deteriorate the siding material and it should be removed. Consult a professional house washing company or look into DIY hose end or concentrate applications.

Remove Mildew from Siding

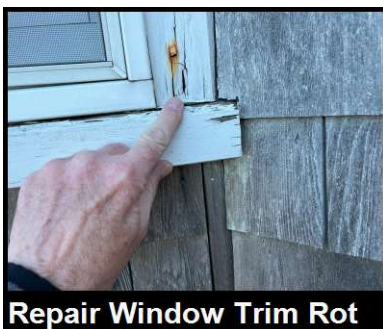
A [M] D NI **Exterior Window Observations:** Some window trim was deteriorated and will need to be repaired.

Repair Window Trim Rot

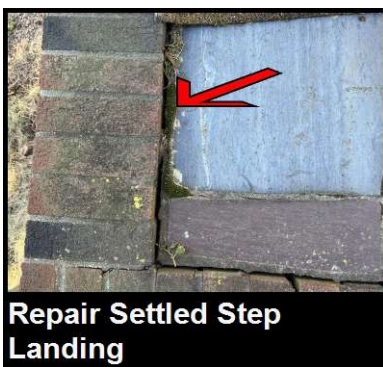
Settlement: Some settlement was noted. Some re-pointing of the mortar is needed.

Repair Settled Step Landing

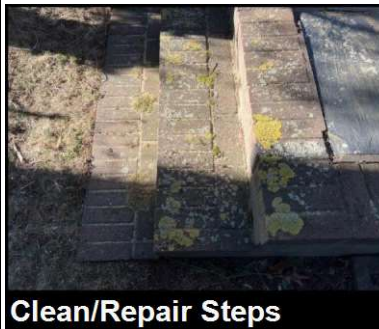
A [M] D NI Condition Of Side Steps: **Deficiencies and/or Defects Noted:** Some areas of the steps surface were covered with moss/mildew. This condition can create a slippery surface, especially during wet conditions. Recommend removal for safety.

Clean/Repair Steps

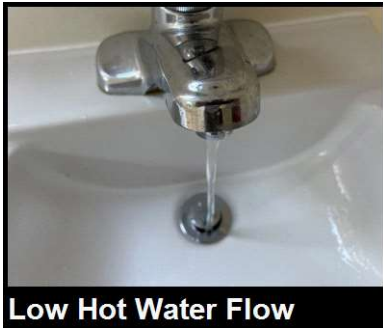
Low Hot Water Flow

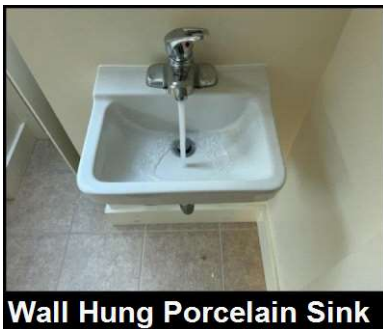
A [M] D NI **2nd Floor Bath: Sink Style:** Porcelain, **Sink Condition:** The sink is functional and in an overall good condition with normal wear.
Fixture Condition: Low water volume on the hot water side is noted ; recommend further evaluation to determine the cause and if corrective action is needed.

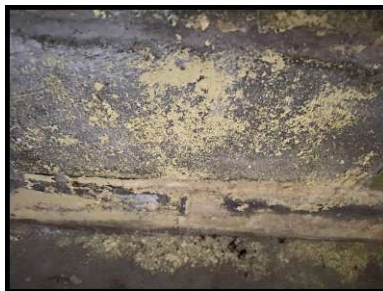
There is evidence of an active moisture problem occurring in the basement. The present condition of the grading may be contributing to this problem.

Efflorescence on Foundation Wall

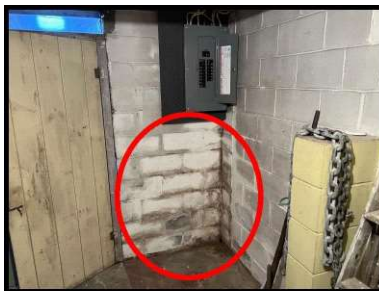
Evidence of Water Leakage

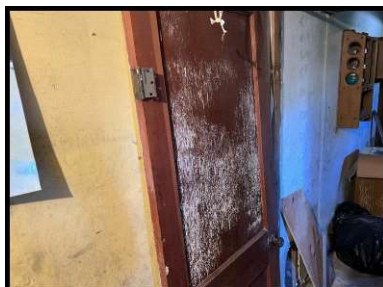
A [M] D NI Visible Microbial Growth: Conductive Conditions: Conductive conditions are existing in the basement for microbial growth.

Microbial Growth on Door

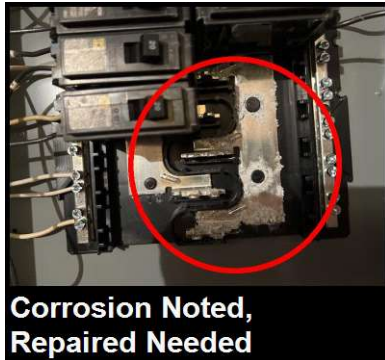
**Corrosion Noted,
Repair Needed**

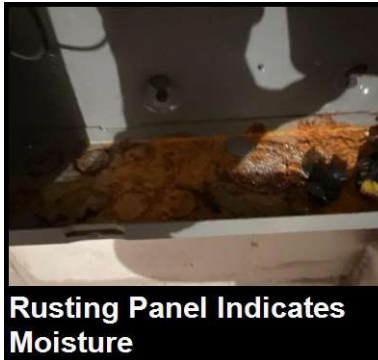
**Rusting Panel Indicates
Moisture**

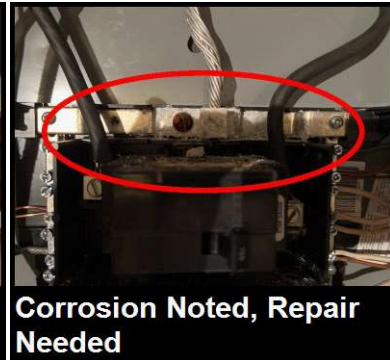
**Corrosion Noted, Repair
Needed**

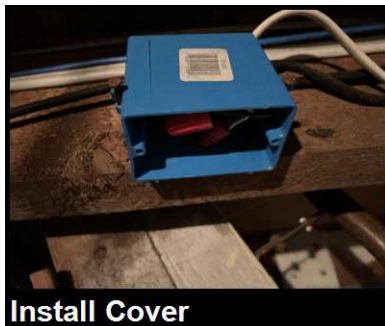
A [M] D NI Basement Structure: **J Box Covers:** Junction box missing cover; replacement needed.

Install Cover

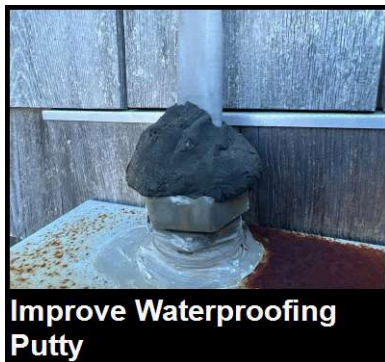
Meter Condition: The meter installation appears to be in an acceptable condition. The weather proofing (putty) at the connection point between the incoming line and the meter box is deficient and needs to be repaired. This condition creates potential for water leakage into the meter box and rust and corrosion was noted inside the panel enclosure.

Improve Waterproofing Putty

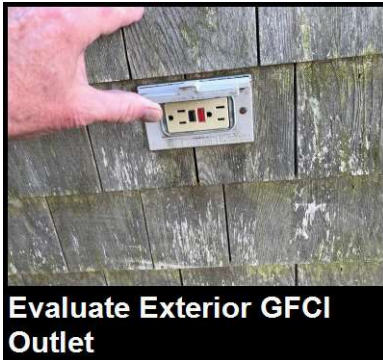
Evaluate Exterior GFCI Outlet

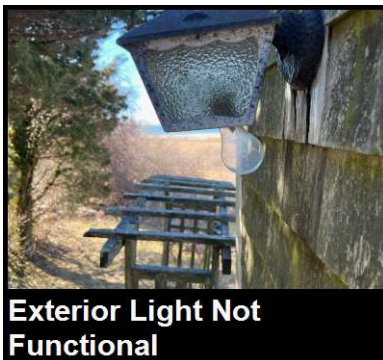
- [A] M D NI Deck Electrical:** Tested light fixtures were functional.
- [A] M D NI Kitchen Interior:** Tested light fixtures were functional.
- [A] M D NI 1st Floor Bath:** Tested light fixture(s) were functional.
- A M D [NI] 2nd Floor Bath:** No light fixtures present in the bath.
- [A] M D NI Basement Structure:** Tested light fixture(s) were functional.
- A M [D] NI Attic & Roof Structure:** Was not functional, repair by a qualified electrician is needed.
- A M [D] NI Entry Foyer:** Was not functional, repair by a qualified electrician is needed.

Exterior Light Not Functional

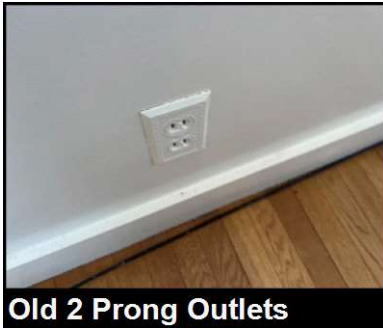
- A M D [NI] **Dining Room:** Note: Older 2-prong ungrounded outlets are installed, not able to test.

Old 2 Prong Outlets

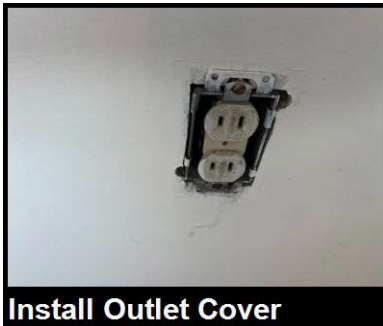
A M D [NI] Bedroom: Note: Older 2-prong ungrounded outlets are installed. Cover plate missing; replacement needed.

Install Outlet Cover

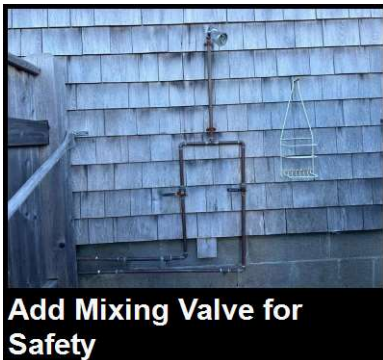
A [M] D NI Outdoor Shower: Water to the outside shower is turned off. No comment is made on condition of the plumbing. No mixing valve is on the outside shower. Recommend adding a mixer to reduce scalding possibilities.

**Add Mixing Valve for
Safety**

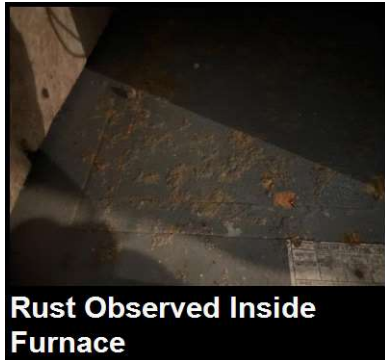
Rust Observed Inside Furnace

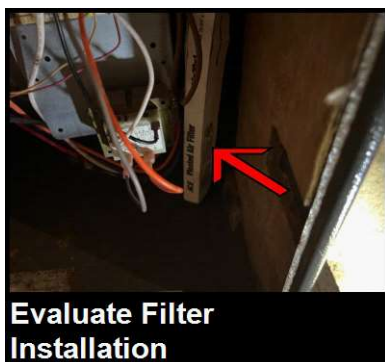
- A [M] D NI Air Filters: Filter Condition:** Filter doesn't seem to be properly installed and will allow dust and particulate matter to bypass the filter medium which could become lodged in the evaporator coil preventing proper airflow. Corrective action needed.

Evaluate Filter Installation

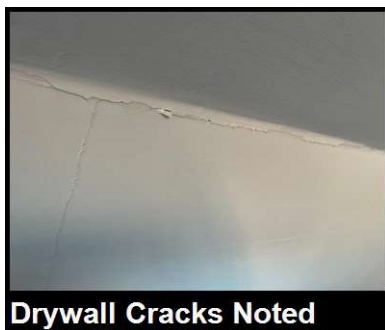
Drywall Cracks Noted

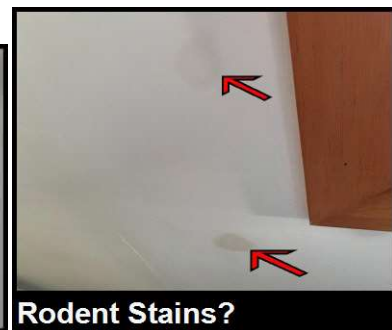
Rodent Stains?

Recommendation: Get a pest inspection of the property from a qualified extermination and pest control contractor. Once the pests have been controlled, ask a painting contractor to provide a cost estimate for painting the ceiling.
