Navigator Home Inspections LLC

Confidential Inspection Report

November 3, 2023

Inspection: 110123_232Shoreline Address: 232 Shoreline Rd

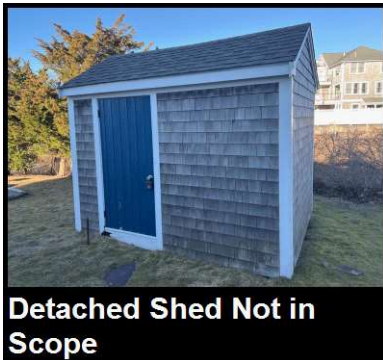
A detached shed was located on the property. Detached structures are beyond the scope of a standard MA home inspection and was not inspected. No comment is made on the condition of detached structures.

Detached Shed Not in Scope

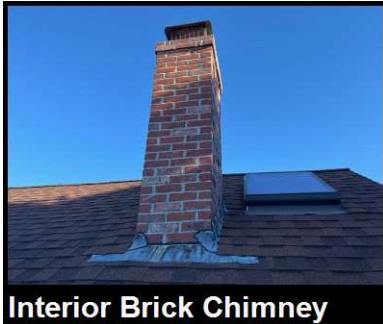
Interior Brick Chimney

- [A] M D NI **Chimney Condition:** The chimney structure was in an acceptable condition at the time of inspection.
- [A] M D NI **Chimney Cap:** There is a rain cap installed. A rain cap protects the flue from the weather, animals, as well as escaping burning embers and sparks.

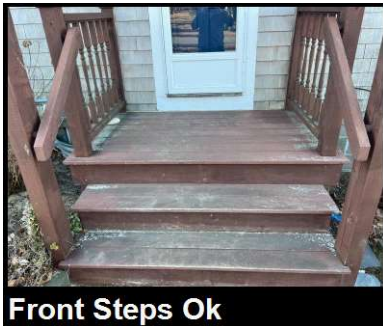
[A] M D NI Condition Of Front Steps: Steps/stairs were serviceable and in an acceptable condition.

Front Steps Ok

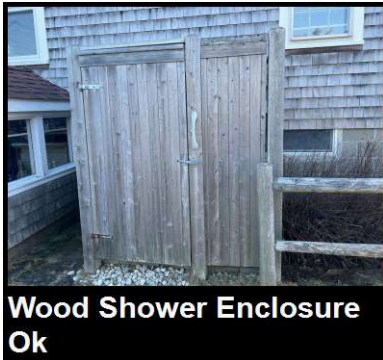
Wood Shower Enclosure
Ok

[A] M D NI Outdoor Shower Enclosure Condition: The outdoor shower enclosure is in an overall acceptable condition.

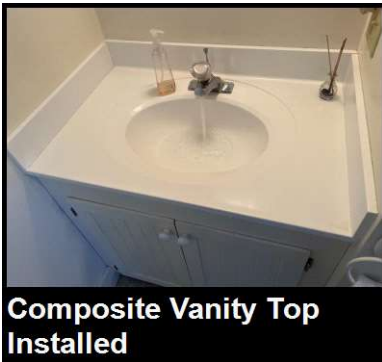
**Composite Vanity Top
Installed**

[A] M D NI **Counter Top Condition:** Counter tops are in an acceptable condition with normal wear.

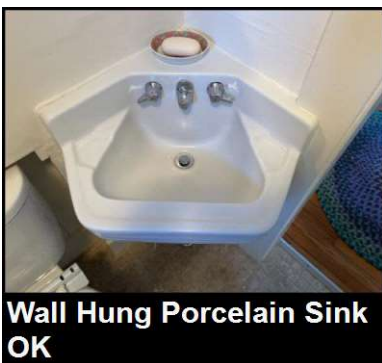
A [M] D NI **Sinks & Fixtures:** **Sink Style:** Porcelain, **Sink Condition:** The sink is functional and in an overall good condition with normal wear. **Fixture Condition:** The drain stopper did not operate properly, repair needed.

**Wall Hung Porcelain Sink
OK**

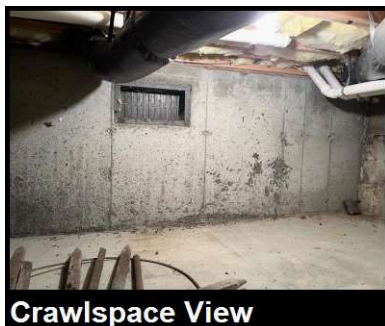
Crawlspace View

[A] M D NI **Condition; Crawlspace View:** Visible portions of the interior foundation perimeter walls appeared to be in an acceptable condition at the time of inspection. Condition of walls are as would be expected for a structure with this type of construction and age.

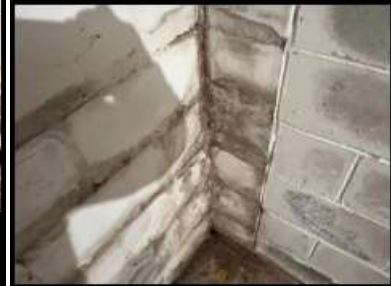
A [M] D NI Visible Microbial Growth: Conductive Conditions: Conductive conditions are existing in the basement for microbial growth.

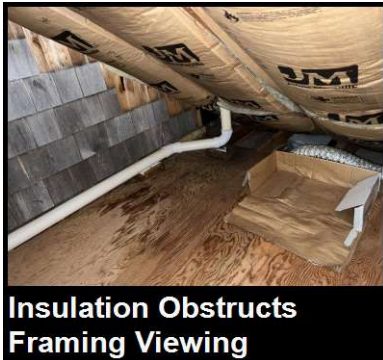
A M D [NI] **Roof Structure:** Not readily accessible and observable.

Insulation Obstructs Framing Viewing

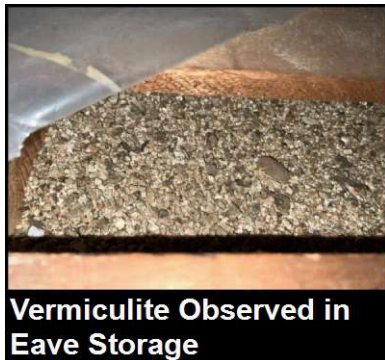
Type of insulation installed is fiberglass batts. Some Vermiculite insulation was observed in the front eave storage.

A M [D] NI Condition Of Attic Insulation: If you have vermiculite insulation in your home, you should assume this material may be contaminated with asbestos and be aware of steps you can take to protect yourself and your family from exposure to asbestos. The EPA recommends that vermiculite insulation be left undisturbed. Airborne asbestos fibers present a health risk through inhalation, so the first step is to not disturb the material, which could release fibers into the air. If you disturb the insulation, you may inhale some asbestos fibers.

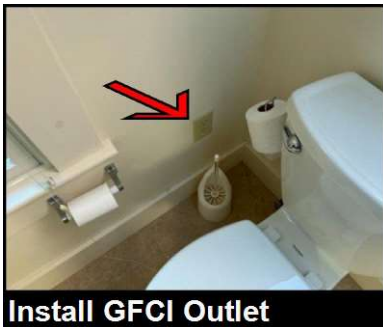
- A [M] D NI **Kitchen Interior:** Tested outlets were functional. Outlet(s) are not GFCI protected. Installation of GFCI outlet protection is recommended for safety.
- A [M] D NI **2nd Floor Bath:** Tested outlets were functional. Outlet(s) are not GFCI protected. Installation of GFCI outlet protection is recommended for safety.

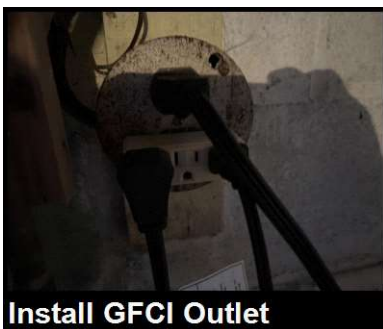
- A [M] D NI **Basement Structure:** Tested outlets were functional. Outlet(s) are not GFCI protected. Installation of GFCI outlet protection is recommended for safety.

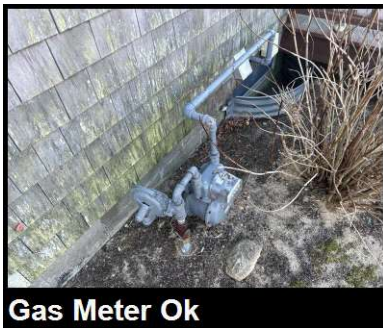
[A] M D NI Gas Service: Gas meter is located at front facing wall. It appears to be in an acceptable condition.

Gas Meter Ok

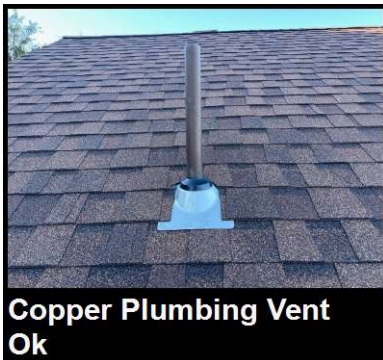
**Copper Plumbing Vent
Ok**

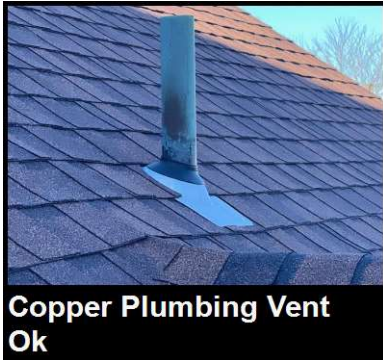
**Copper Plumbing Vent
Ok**

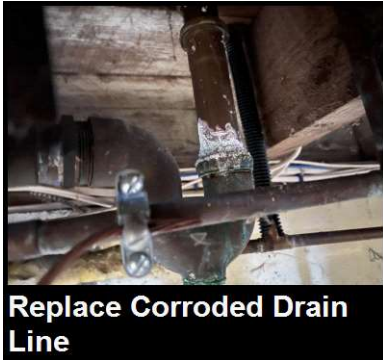
A [M] D NI Basement Structure: Corrosion: Corrosion/encrustation noted at some locations where pipe unions and fittings were installed that is more than would typically be expected. Corrosion can be the precursor for leaks. Further evaluation is advised to determine if repairs are needed.

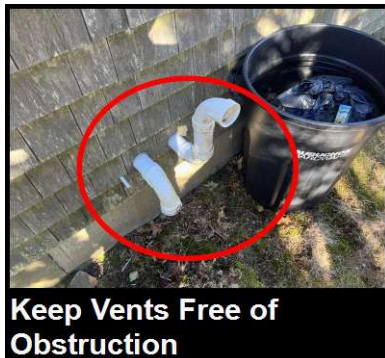
Keep Vents Free of Obstruction

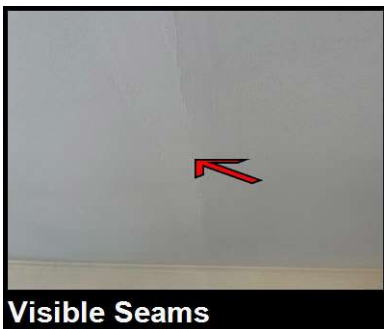
A [M] D NI Dining Room: Ceiling Covering Material: Drywall. Some drywall seams were observed at various locations that will need some repair.

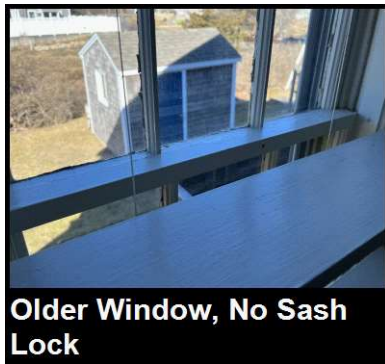
- [A] M D NI **Kitchen Interior:** Window(s) functional at time of inspection.
- [A] M D NI **1st Floor Bath:** The window(s) is functional.
- [A] M D NI **2nd Floor Bath:** The window(s) is functional.
- [A] M D NI **Entry Foyer:** The window(s) is functional.
- A [M] D NI **Dining Room:** The newer window(s) are functional. There is an older window in this room that was obstructed and not able to test. The window is missing the sash lock.

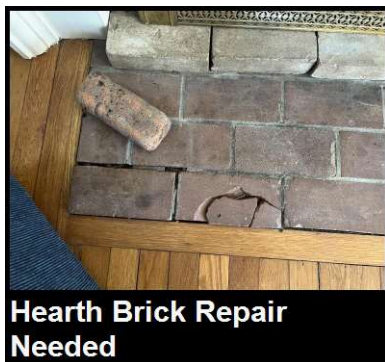
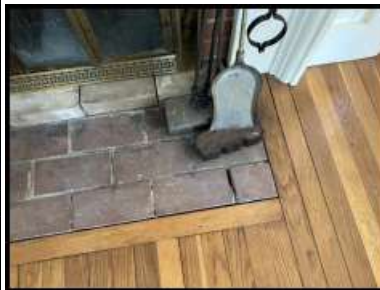
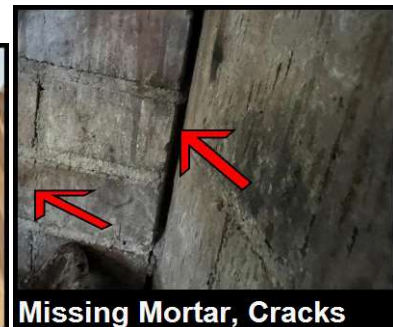
A M [D] NI Condition: **Mortar Joints:** Mortar joints are deteriorated.

Damper: Damper did not properly operate. The flue damper needs adjustment or repair.

Hearth: Needs repair.

Evaluation is needed by a qualified masonry contractor.

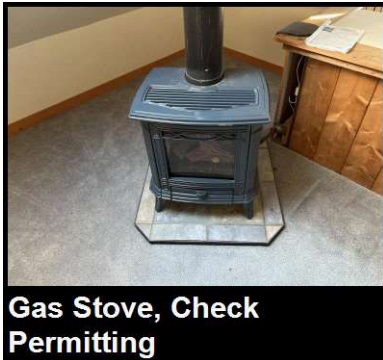
Type:
Free-Standing gas stove.

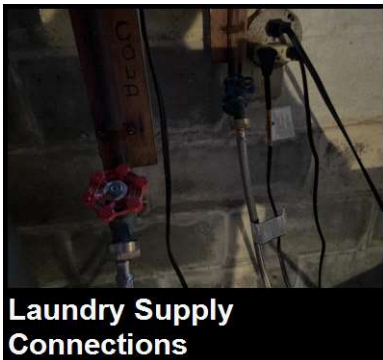
Laundry Supply Connections

A M D [NI] Hose Bibs / Hookups: Individual valves were installed. Valves are not operated as part of a standard MA home inspection.
